Testing of the Structure of Carbon Fiber Reinforce Polymer Composite Panels Due to Blast Explosion Using C-Scan Ultrasonic Test Aid

Abstract: Ultrasonic testing (ultrasonic testing) utilizes high-frequency sound waves to detect damage to a material, composite or workpiece. This test is commonly used to inspect materials made of metal or plastic, as long as the material is not absorbent. In its application, ultrasonic testing uses a workpiece vibrating device called a probe. Ultrasonic waves emitted by the probe will vibrate the atoms in the test material or workpiece. The most ideal method for inspecting defects in composites is the immersion method. The size of the immersion tank must be considered as well as possible in order to accommodate the test object of the required size. C-Scan provides data about the location, size, and shape of the defects that occur, besides C-Scan with very high resolution can produce very detailed images. The specimen tested was a laminated composite made of C-glass/epoxy with material properties. The specimen is in the form of a square with a size of 150mmx100mm (referring to ASTM-D7136-12), the test specimen has a thickness of 2.5 mm and is given a

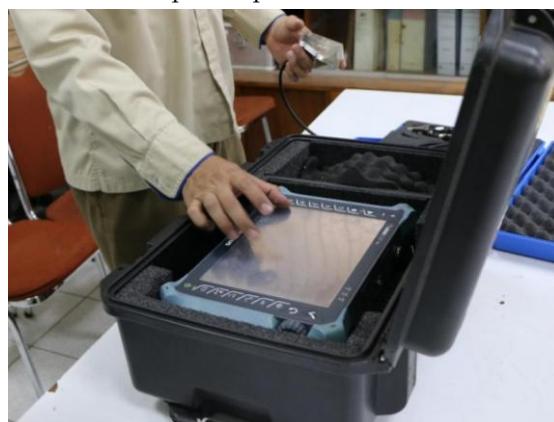
Figure 6. Ultrasonic C-Scan with a phased array probe

Ultrasonic C-Scan at 5 MHz with *phased array probe*. The *phased array probe* is a cutting-edge technology incorporating multiple crystals into a single *probe*. The tool's shape is depicted in **Error! Reference source not found.6**.

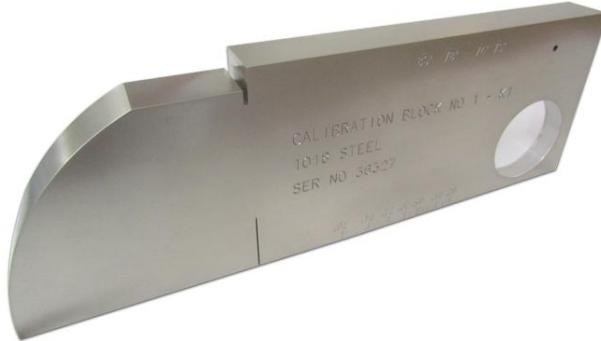
Figure 8. SRB Type IIW (Admin, 2019)

Error! Reference source not found.⁷ shows some of the test equipment commonly used to detect damage to steel components.**Error! Reference source not found.**⁸ shows a *standard reference block* (SRB) type IIW (*international institute of welding*) used to calibrate the tool.

Error! Reference source not found.⁸ depicts an SRB made of 1016 steel. The thickness of the SRB is 25 mm, according to the size details shown in**Error! Reference source not found.**⁹. The test equipment is placed perpendicular to the thickness of steel with a thickness of 25 mm to calibrate the tool detection capability. Different thickness surfaces or materials are required to calibrate the capability of tools at different thicknesses. A polymer-based component of the SRB can be seen in**Error! Reference source not found.**⁸. The tool's ability to detect a thickness of 50 mm in steel is calibrated using parts made of this polymer.
